**PHASE I
ENVIRONMENTAL SITE ASSESSMENT
(LIMITED TO ASTM E 1527-05 SCOPE)
APPROXIMATELY 525-ACRE REUNION RANCH
SOUTH OF FARM-TO-MARKET ROAD 1826
DRIFTWOOD, HAYS COUNTY, TEXAS
HJN 110142 PI**

**TAYLOR MORRISON OF TEXAS, INC.
AUSTIN, TEXAS**

JANUARY 2012

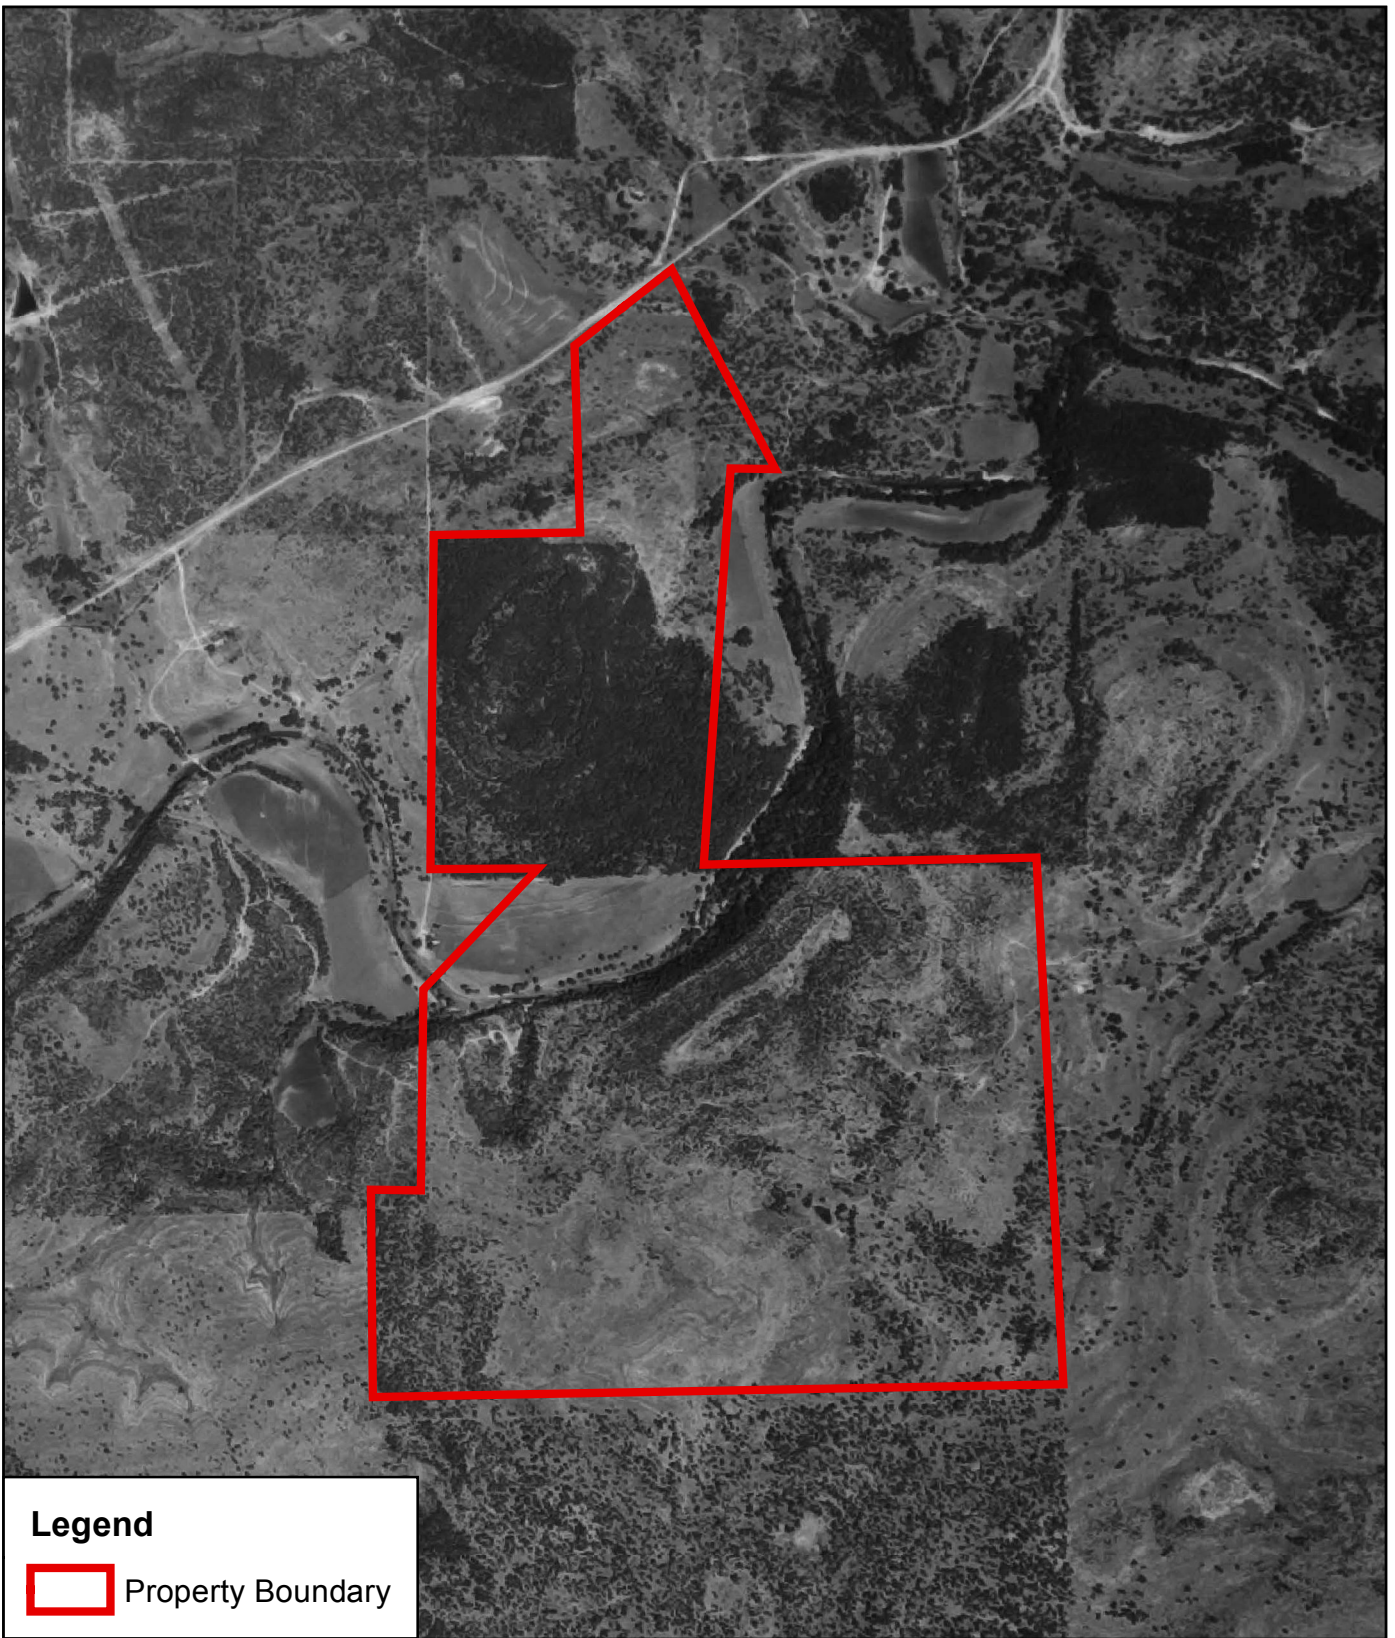
FIGURE 4-4

The 1962 aerial photograph (Figure 4-4) revealed no significant visible changes to the Property or immediately surrounding properties. No recognized environmental conditions were evident on the Property or immediately surrounding properties based upon a review of the aerial photograph.

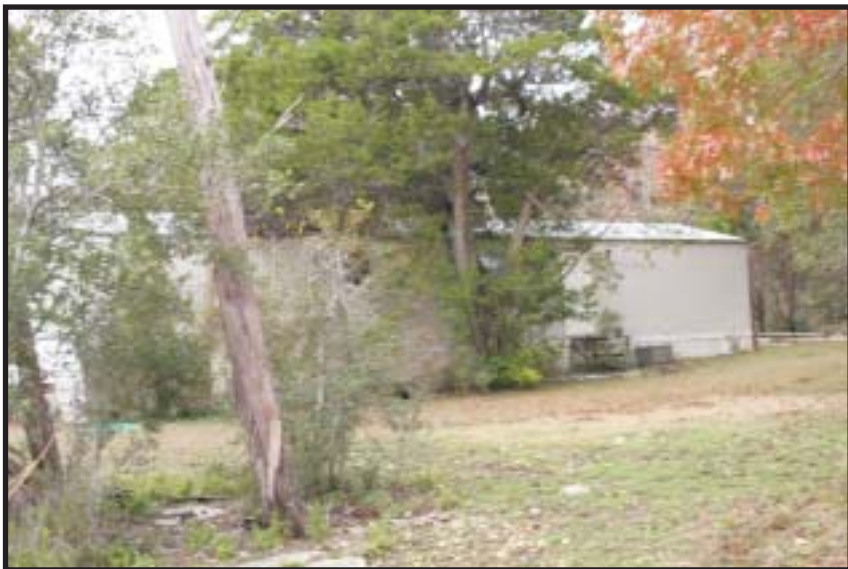
PHOTO 1

**View of mobile SFR located
on the central portion of
the Property**

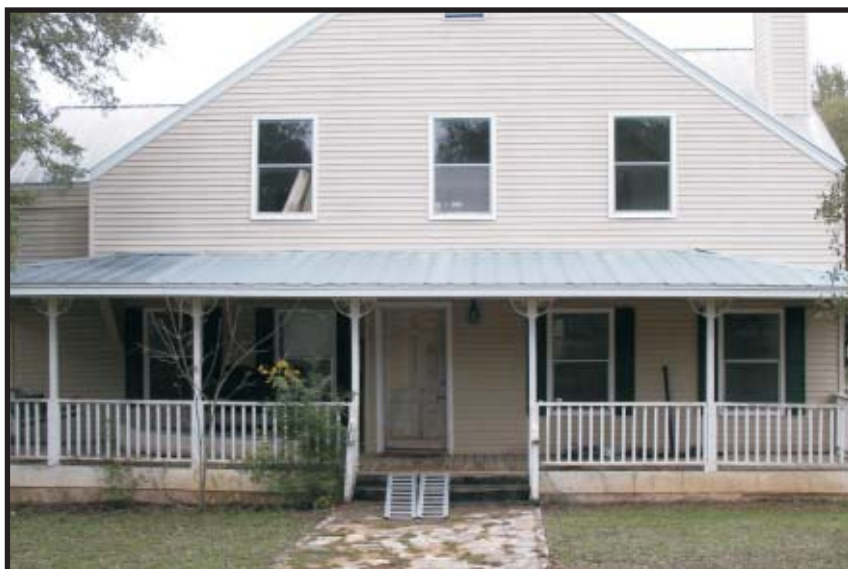
PHOTO 2
View of on-site SFR

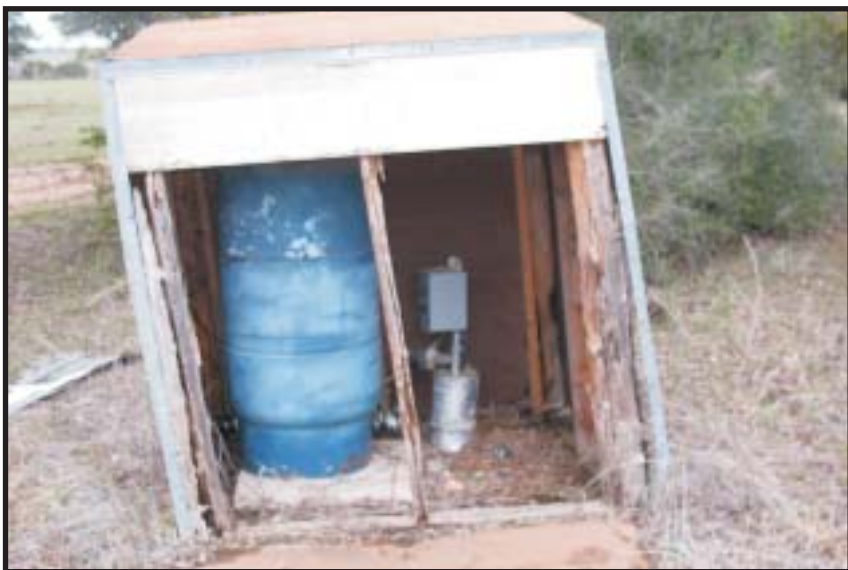
PHOTO 3

**View of functioning water well
located on the central portion
of the Property**

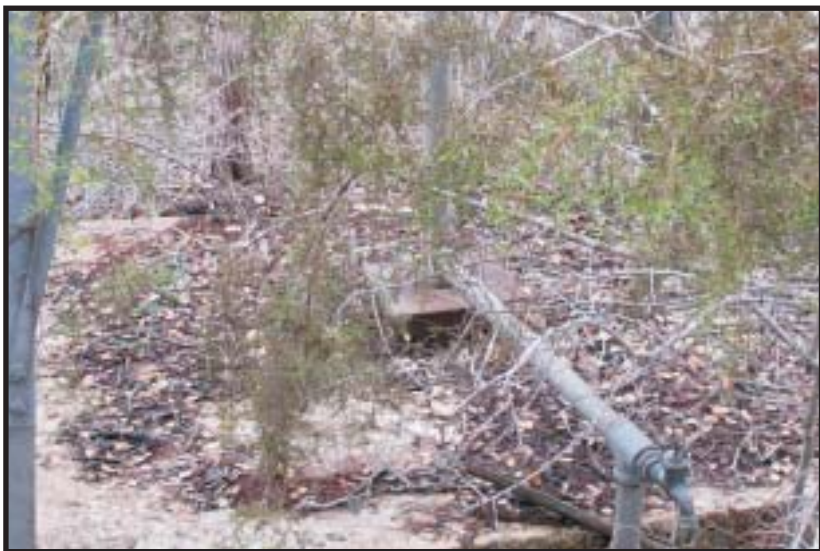
PHOTO 4

Horizon observed 1 operable water well located on the central portion of the Property. Additionally, Horizon observed 1 windmill and water well on the southern portion of the Property; however, it appeared to not be in use at the time of Horizon's field reconnaissance (Appendix C, Photos 3 and 4).

View of abandoned water well located on the southern portion of the Property

Horizon does recommend that all recognized environmental conditions and debris located on the Property be removed and disposed of at approved facilities for those contents. At the time of removal of these products, should any additional surface staining be observed, Horizon recommends that those areas be examined by an environmental professional to determine if any significant staining could have potentially caused soil and or groundwater contamination. Horizon also recommends that any water well that is not intended for current or future use be properly plugged and abandoned.

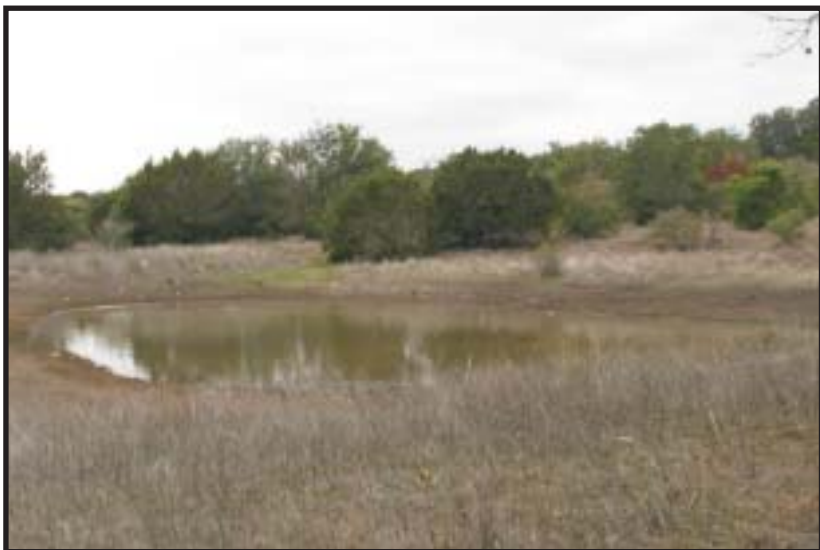
PHOTO 5

In the southern portion of the Property, Horizon observed a manmade stock tank, located on a hillside and served by a windmill-powered water well that did not appear to be in use at the time of this report (see Figure 6-1). The stock tank was approximately 1/2 acre in size with an approximate depth of 10 feet and is located at the headwaters of an unnamed tributary of Bear Creek (Appendix C, Photo 5). A sheet metal deer blind was located southeast of the water well.

View of on-channel stock pond located on the southern portion of the Property

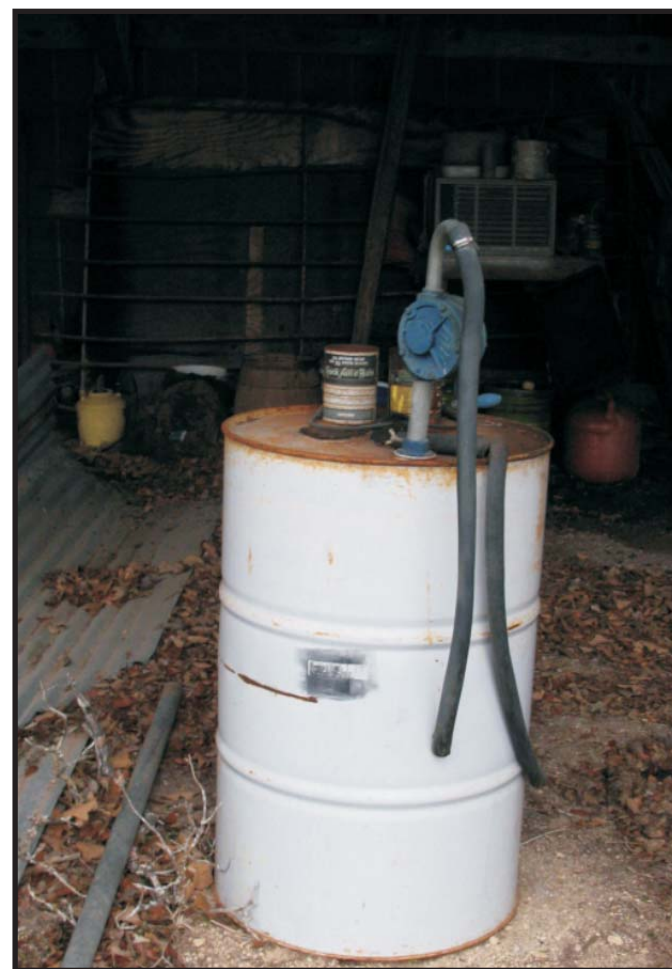
PHOTO 6

1. Horizon observed two 55-gallon drums containing an unlabeled petroleum product and several 5-gallon containers of automotive engine oil and/or petroleum product in the sheet metal pole barn located on the central portion of the Property. Several small pesticide sprayers, automotive tires, small gasoline containers, and used engine oil filters were also observed within the same vicinity and within an on-site sheet metal pole barn that appeared to be utilized for vehicle maintenance.

View of 55-gallon drum containing used motor oil

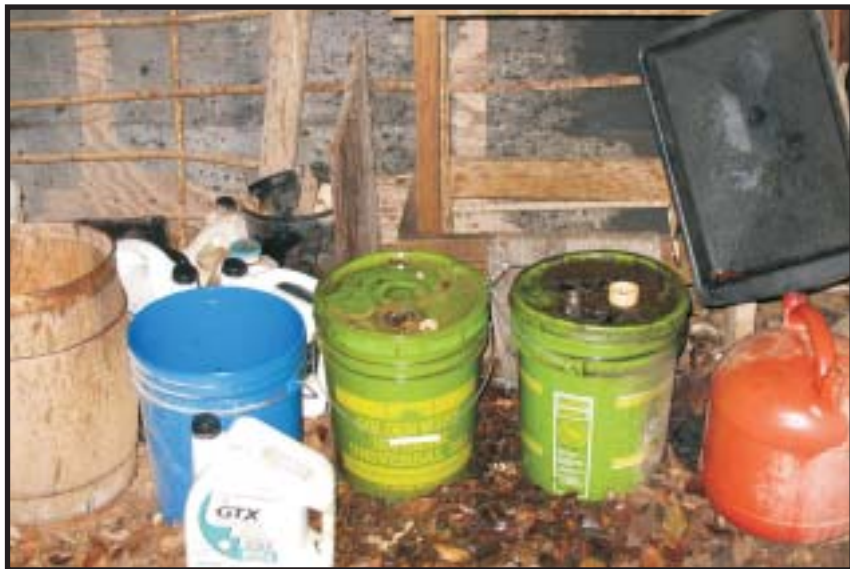
PHOTO 7

3. Horizon did observe an area within a sheet metal pole barn that had minor surface soil staining that appeared to be engine oil.

View of 5-gallon buckets and gasoline containers associated with surface soil staining

Upon proper cleanup of the on-site soil staining and removal of debris with a follow-up inspection, Horizon recommends no additional investigations, studies, or sampling efforts for any hazardous substances on the Property at the time of this report.

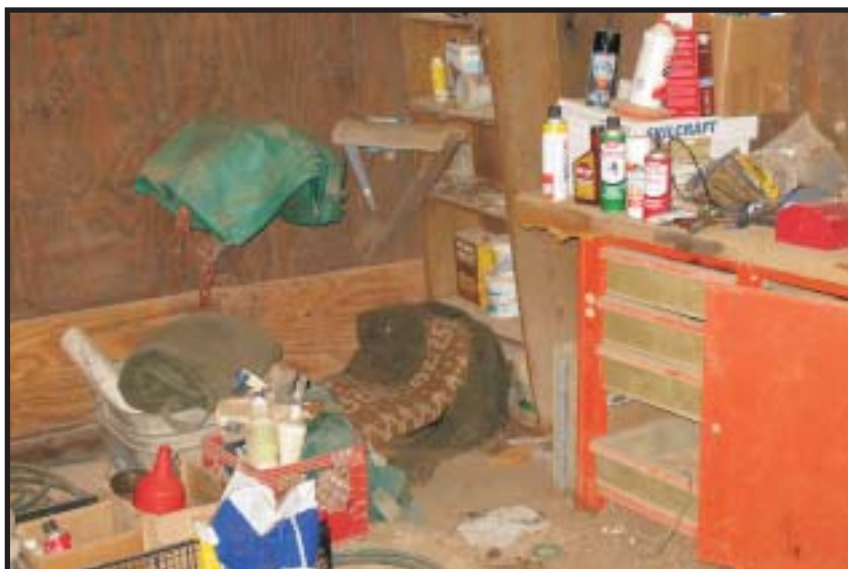
2. Horizon also observed 1-gallon exterior and/or interior paints cans, gasoline containers, and commonly used equine supplies including wormer and pest control medications. These contents were all contained within an enclosed tack room of an open sheet metal pole barn with horse stables located on the central portion of the Property.

PHOTO 8
View of contents within on-site horse stable

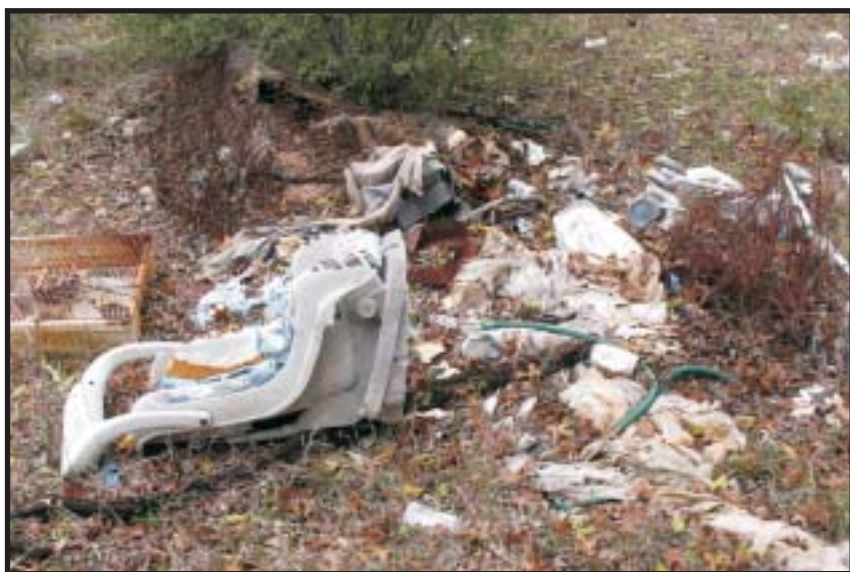
PHOTO 9

Additional findings that are not considered recognized environmental conditions include other debris piles containing lumber, sheetrock, plywood, plastic bags, and outdoor carpeting. A mobile flatbed trailer was also observed along the northern portion of the Property that contained refuse lumber and fencing materials. On the southern portion of the Property, Horizon also observed 1 stock pond and a water well that appeared to have been abandoned.

View of scattered debris observed on the central portion of the Property

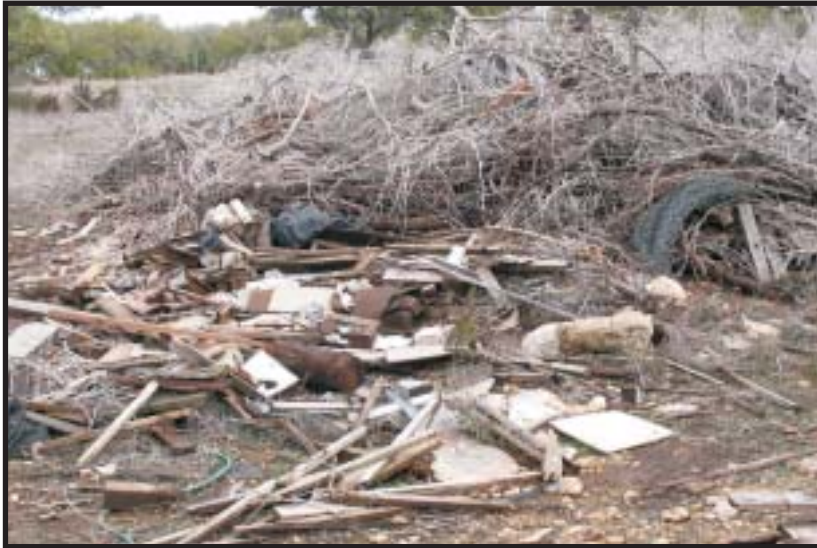
PHOTO 10
View of debris pile observed on the northern
portion of the Property

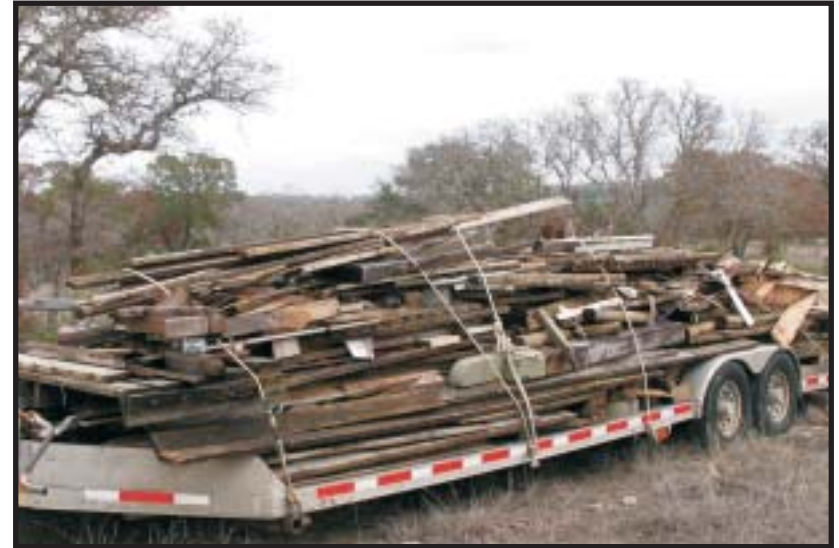
PHOTO 11
View of refuse lumber on trailer located on the
northern portion of the Property

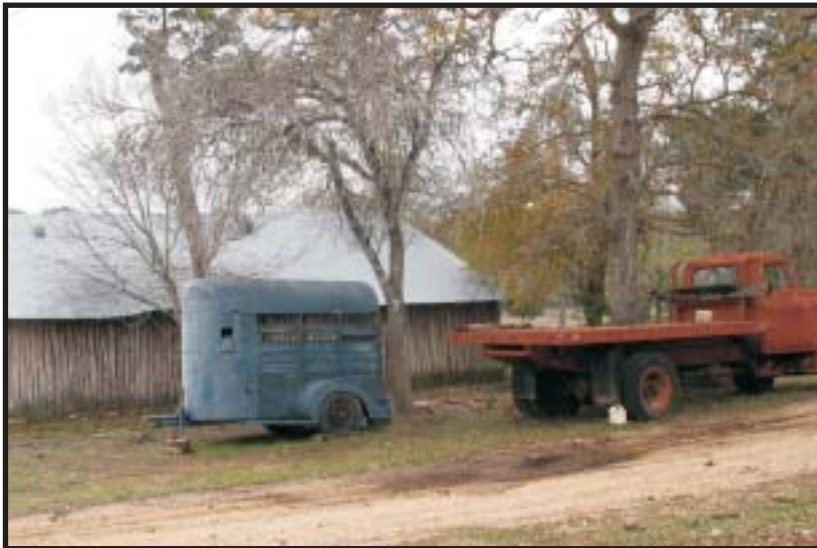
PHOTO 12
View of flatbed truck, trailer and pole barn located
on the central portion of the Property

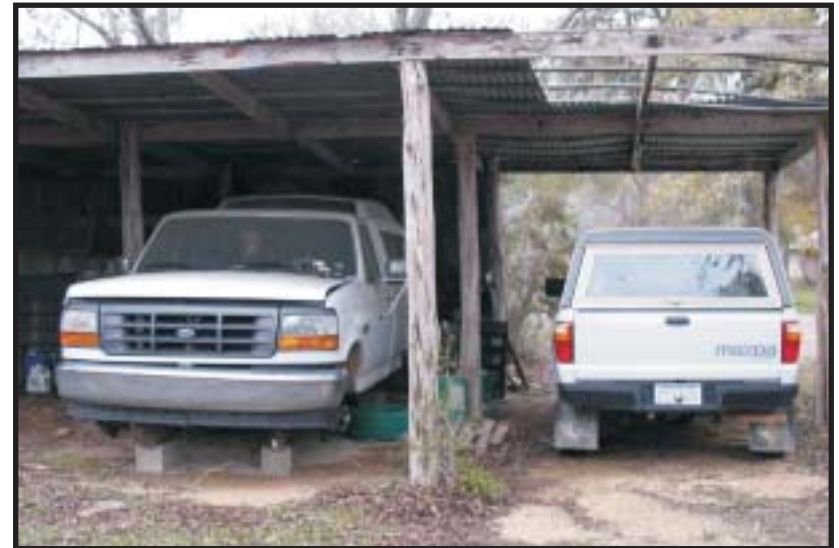
PHOTO 13
View of abandoned vehicles located on the central
portion of the Property
